# IRIS-4

Firmware 4.10.2

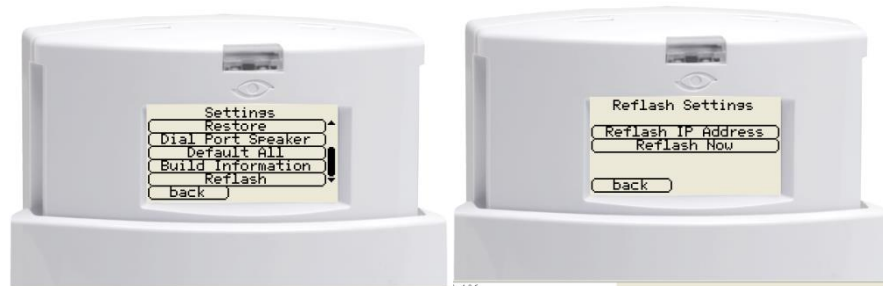
Alternatively, for local upgrade, connection to the reflash server can be instigated from the installer menu, Settings->Reflash:

The reflash IP address is set by default to AddSecures's reflash server (195.59.117.164) and does not need to be changed unless another reflash server is to be used.

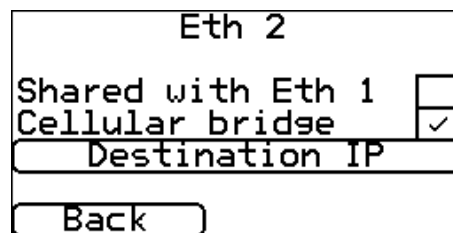
IRIS terminals with cellular connection and two Ethernet ports (IRIS-4 440, IRIS-4 640D) offer the possibility of bridging between the cellular connection and the second Ethernet port (Eth 2). In this case a DHCP server is also provided on the Eth 2 port. This mode of operation is enabled when a SIM card is fitted to the terminal and has attached to the SIM provider's cellular data network and when the Ethernet 2 port is set to 'Cellular bridge' mode, as shown below.

Note - only a single Ethernet device is supported.

IP TCP and UDP packets sent to the SIM card IP address are bridged to the terminal Eth2 port and vice-versa. Note that other IP protocol types are not bridged.

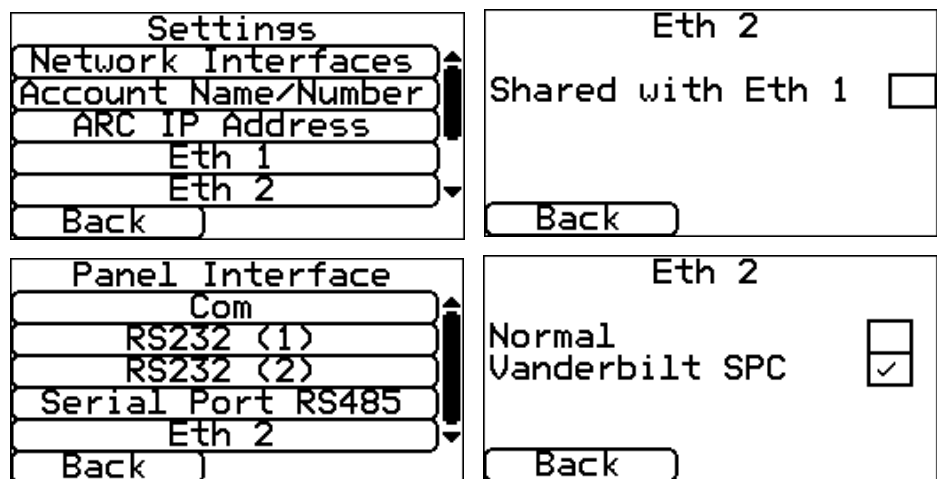
- 4) The IP Address and Remote Access settings have been removed from the terminal's touch screen menu as they are no longer required. When selecting Siemens mode, the option 'Shared with Eth 1' is automatically deselected.

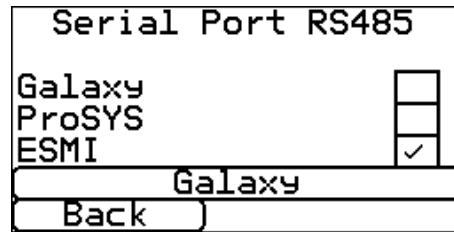
Support for Fire Panel serial interfaces has been extended to include ESMI fire panels on the RS485 port.

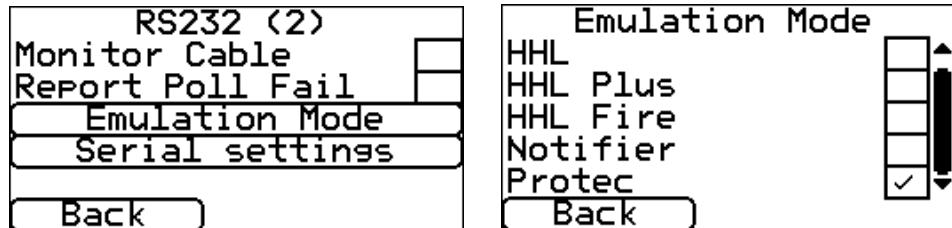
Support for Fire Panel serial interfaces has been extended to include Protec panels on serial port 2.

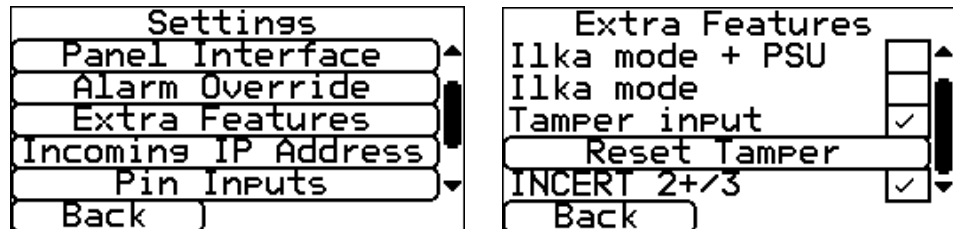
If a tamper switch activation occurs (including activation of the tamper input on non-cased variants), it does not restore automatically, it must be restored via the Touch Screen->Extra Features menu 'Reset Tamper' button.

If the tamper physical condition has been restored before 'Reset Tamper' has been selected, the reset button will be removed and the tamper restore message will be sent to the monitoring centre. If not, the button will be removed and the tamper restore will be sent when the condition is restored.

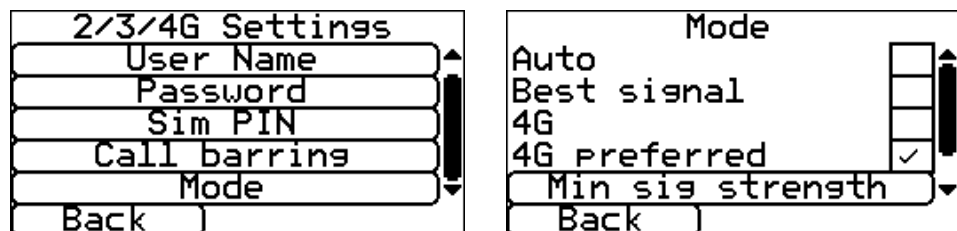
A Cellular Mode setting menu has been added to the 2/3/4G settings menu to select the Cellular technology used.

The options available are:

- Auto – the terminal will adopt the technology that is selected by the combination of the SIM card configuration and the network operator.
- Best signal – the terminal will select the technology with the highest signal strength (the default setting in the previous firmware release).

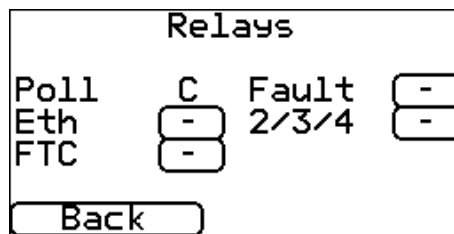
A relay can be selected to indicate 'Fail to Communicate'. This is found in the 'Trouble Reporting' 'Via Relays' menu.

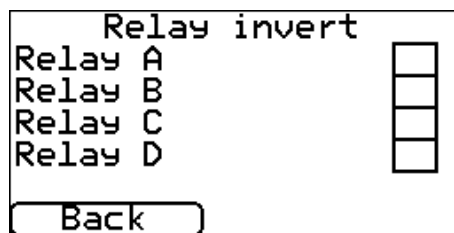
A relay invert setting is available in the 'Relays' menu.

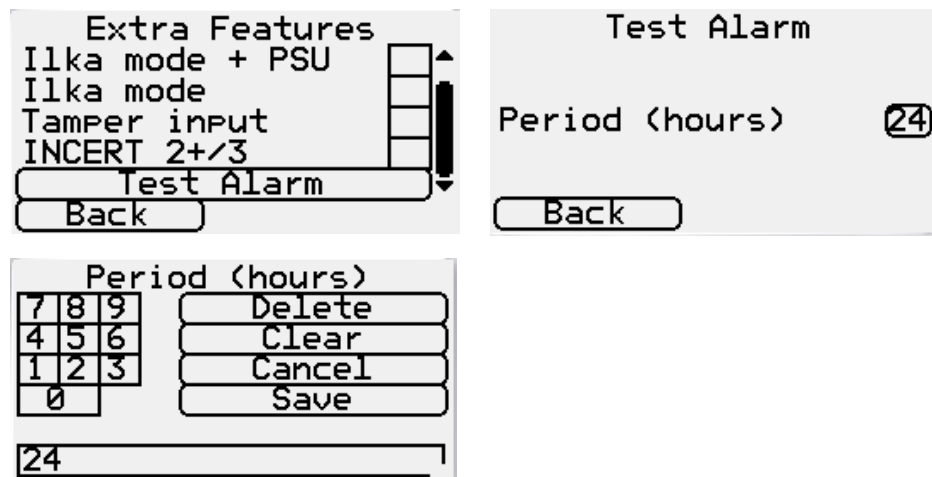
In cases where the IRIS terminal is not connected to an alarm panel that can itself generate a regular test alarm (e.g. when inputs are used), it can be convenient for the terminal to generate a regular test alarm. This gives the monitoring centre a consistent way to monitor end-end connectivity across many installations. Previously IRIS-4 4xx terminals have supported test alarms over PSTN only, but not over all paths (i.e. the first path available).

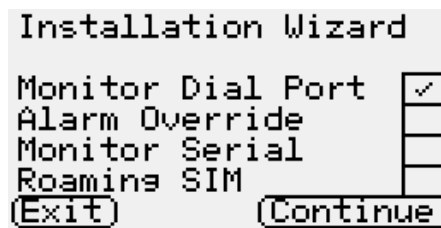
On the IRIS Touch NG series, the installation wizard included a selection tick box for 'Roaming SIM', as below.

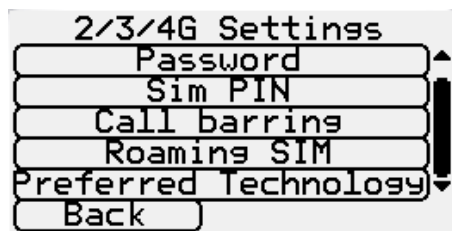
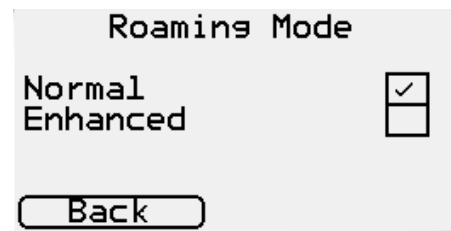
This was removed from this menu on the IRIS-4 series because the meaning of the selection was ambiguous. The intention of the setting is 'enhanced' roaming where the terminal monitors the signal strength of the signal from all available cellular service providers and selects the one with the highest signal strength. It was identified that the setting was being selected by some installers if the SIM card in use is a roaming enabled SIM card and where there was no need for the selection of the operator with the strongest signal, as described above. This could result in intermittent trouble being reported by the terminal to the monitoring centre. The selection of this feature, for those who need it, has therefore been moved to the settings menus.

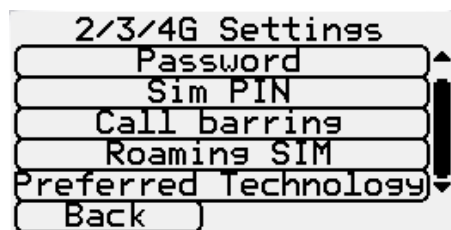
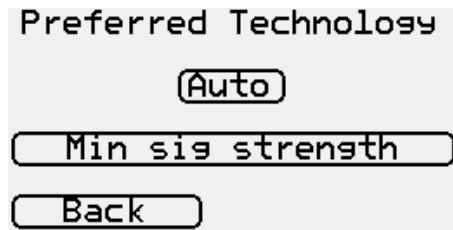
#### 4.10.2 Selection of Preferred Technology

This setting allows the installer to select the preferred technology (Auto, 2G, 3G or 4G) used by the dialler for its cellular connection and the minimum signal strength required for the connection. If the signal strength is not at the required level (default is 10), the terminal will

use a different technology that does meet the requirements. A setting of 'Auto', which is the default, instructs the terminal to select the technology with the highest signal strength, as with IRIS Touch NG terminals.
