IRIS-4

Firmware 4.11.0

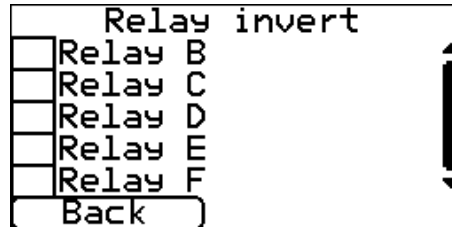
2.8 Revised Touch Screen Layout

The Touch screen and virtual Touch screen layout has been changed and tick boxes that were previously on the right hand side have been moved to the left hand side, as shown below. This has allowed more space to be allocated to the scroll bar (where displayed) to make it easier to use.

ID	Details
T10517	Add buffer overflow protection in cellular module interface to avoid possible terminal reset under loaded conditions.
T7447, T10781, T10822	Increased touch screen scrollbar sensitivity area and moved tickboxes to the left side of the corresponding text. This improves the user experience when using the scroll bar.
T9496	New feature: Add support for removing dial port line voltage. This allows line powered terminals to be reset remotely if required.
T9978	New feature: Add support for Intercom mode, with provision for deleting from or adding to dial digit strings sent by an Intercom panel.
T10374	Set default paths to use on Edge VS000 to Cellular only (%I25=10) so fault not shown when Ethernet is not connected. Earlier versions are also defaulted to this on reflash. This is because Ethernet cannot be used with this terminal. Associated with this change the following defaults are removed from AddSecure Connect mode and the corresponding settings on the Touch interface are re-enabled: Paths to use, monitor dial port, monitor serial port, report poll fail on serial port, monitor pin inputs, poll fault relay = relay C, relay C relay follower.

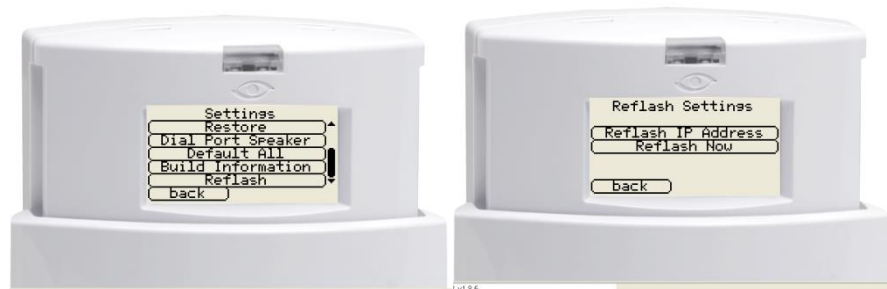
Alternatively, for local upgrade, connection to the reflash server can be instigated from the installer menu, Settings->Reflash:

The reflash IP address is set by default to AddSecure’s reflash server (195.59.117.164) and does not need to be changed unless another reflash server is to be used.

Refashing can be instigated remotely via the IRIS Secure Apps system to which the terminal is reporting, thereby saving the need for a site visit. This can be done either by using the Reflasher App within IRIS Secure Apps or within the IRIS Secure Apps Dialler Dialogue App, by instructing the terminal to ‘Start Dialler Management’ to the reflash server IP address (see below).

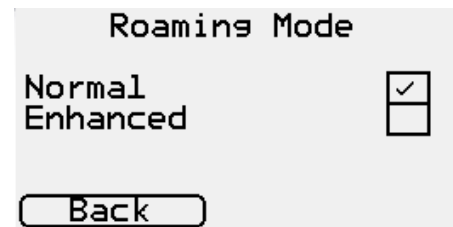
This was removed from this menu on the IRIS-4 series because the meaning of the selection was ambiguous. The intention of the setting is 'enhanced' roaming where the terminal monitors the signal strength of the signal from all available cellular service providers and selects the one with the highest signal strength. It was identified that the setting was being selected by some installers if the SIM card in use is a roaming enabled SIM card and where there was no need for the selection of the operator with the strongest signal, as described above. This could result in intermittent trouble being reported by the terminal to the monitoring centre. The selection of this feature, for those who need it, has therefore been moved to the settings menus.

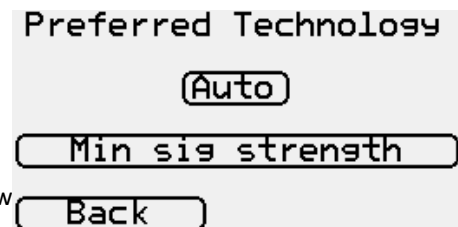
4.14.2 Selection of Preferred Technology

This setting allows the installer to select the preferred technology (Auto, 2G, 3G or 4G) used by the dialler for its cellular connection and the minimum signal strength required for the connection. If the signal strength is not at the required level (default is 10), the terminal will use a different technology that does meet the requirements. A setting of 'Auto', which is the default, instructs the terminal to select the technology with the highest signal strength, as with IRIS Touch NG terminals.
