IRIS-4

Firmware 4.14.0

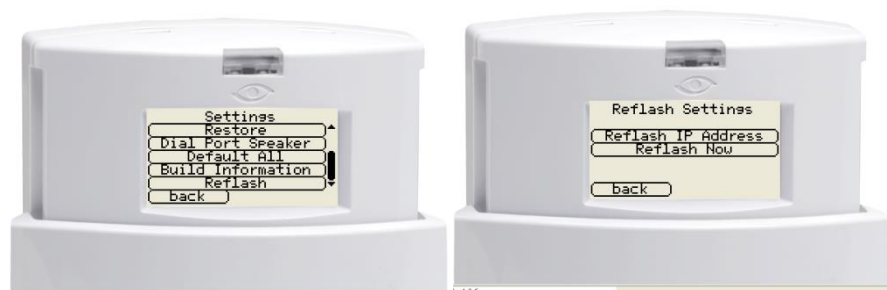
Alternatively, for local upgrade, connection to the reflash server can be instigated from the installer menu, Settings->Reflash:

The reflash IP address is set by default to AddSecures's reflash server (195.59.117.164) and does not need to be changed unless another reflash server is to be used.

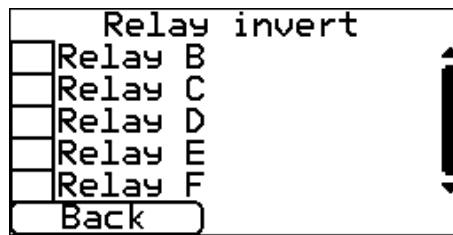
The Touch screen and virtual Touch screen layout has been changed and tick boxes that were previously on the right hand side have been moved to the left hand side, as shown below. This has allowed more space to be allocated to the scroll bar (where displayed) to make it easier to use.

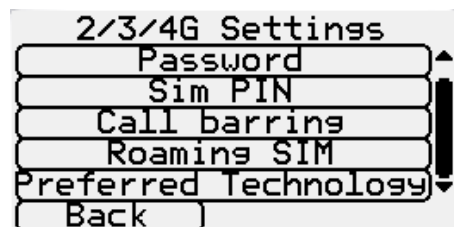
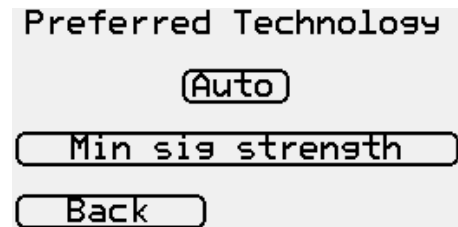
4.18.2 Selection of Preferred Technology

This setting allows the installer to select the preferred technology (Auto, 2G, 3G or 4G) used by the dialler for its cellular connection and the minimum signal strength required for the connection. If the signal strength is not at the required level (default is 10), the terminal will use a different technology that does meet the requirements. A setting of 'Auto', which is the default, instructs the terminal to select the technology with the highest signal strength, as with IRIS Touch NG terminals.
